**KWIK STOP & DELI, INC
ROUTE 15
HARDWICK, VERMONT
PHASE I ENVIRONMENTAL SITE ASSESSMENT**

June 29, 2001

KWIK STOP & DELI, INC Route 15 Hardwick, Vermont

PHASE I ENVIRONMENTAL SITE ASSESSMENT

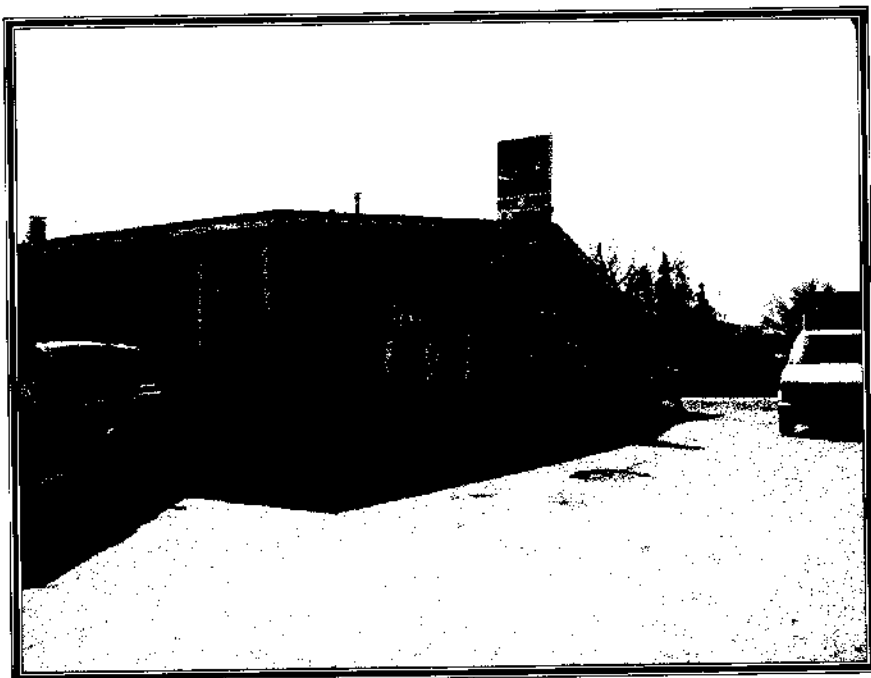
Photo 1: Kwik Stop & Deli Inc

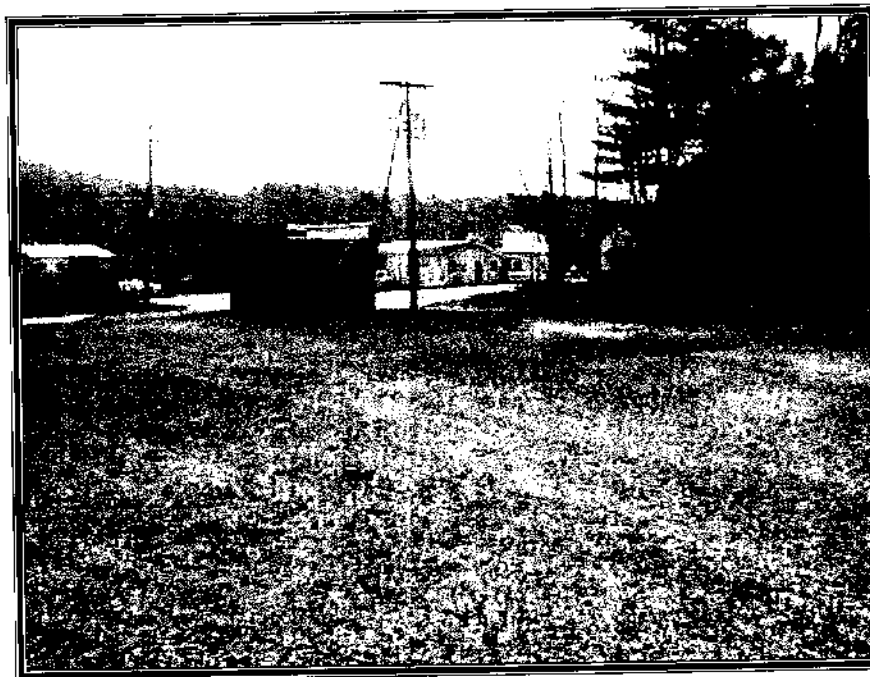
Photo 3: Town Water Supply Well

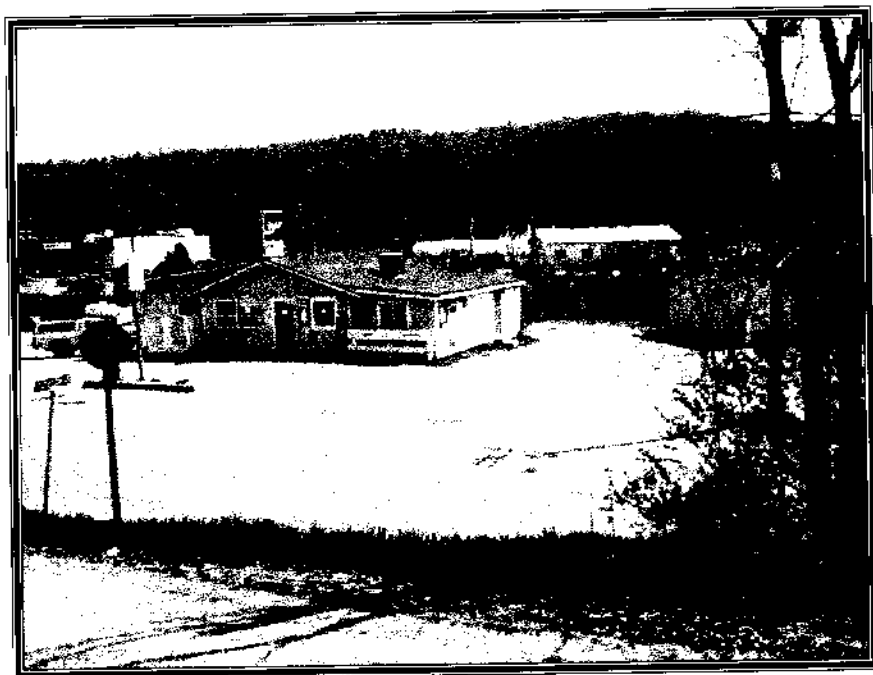
Photo 2: Facing toward the east/northeast (note topography)

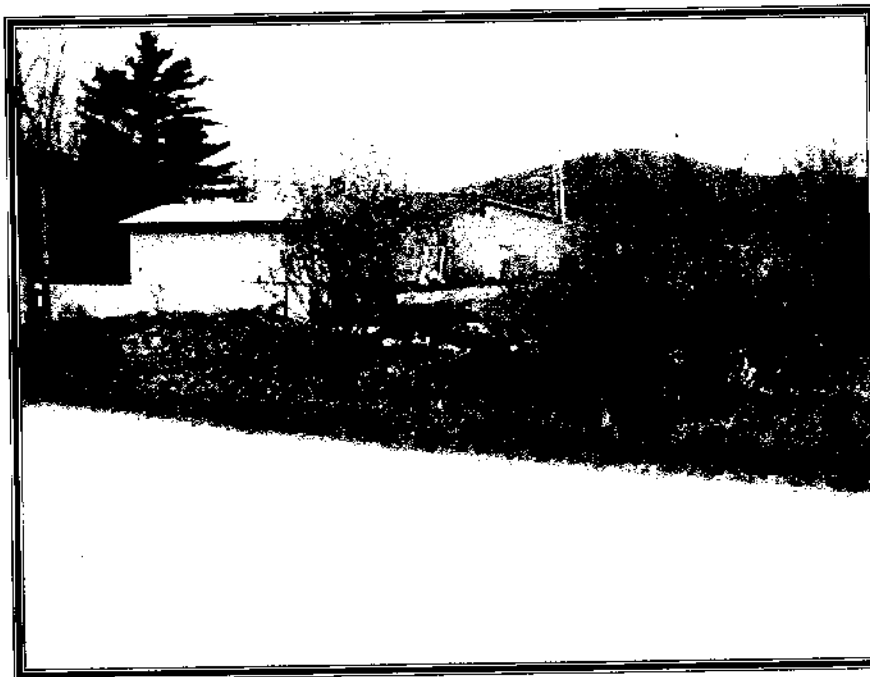
Photo 4: Wet drainage area on eastern side of property

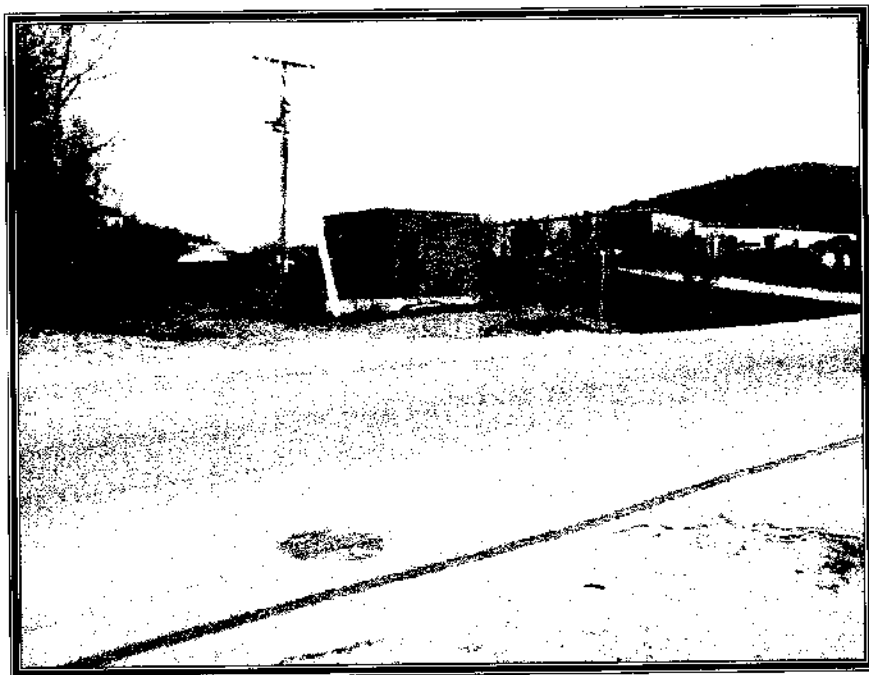
Photo 5: Town Water Supply Well (from Kwik Stop property)

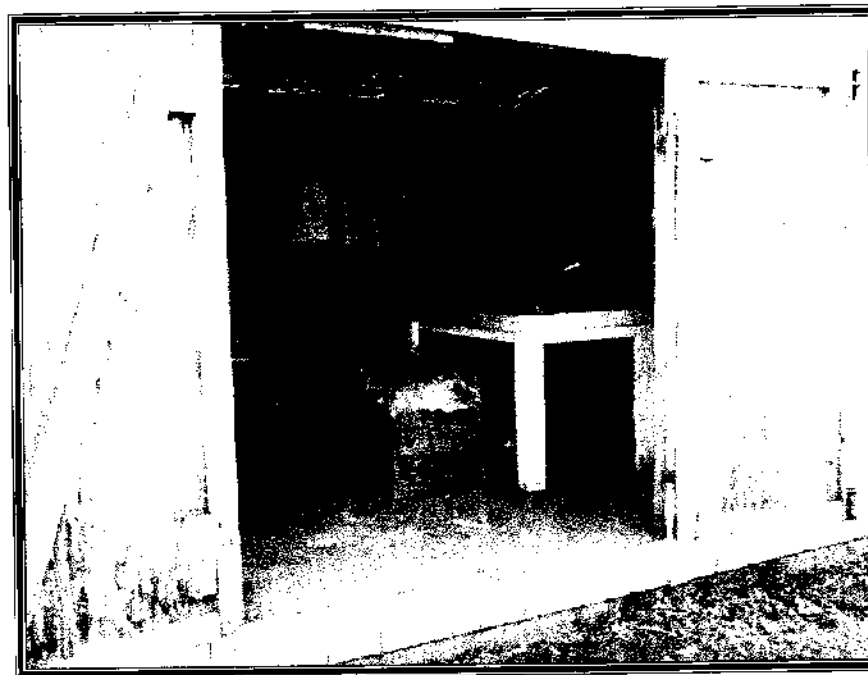
Photo 7: Storage shed

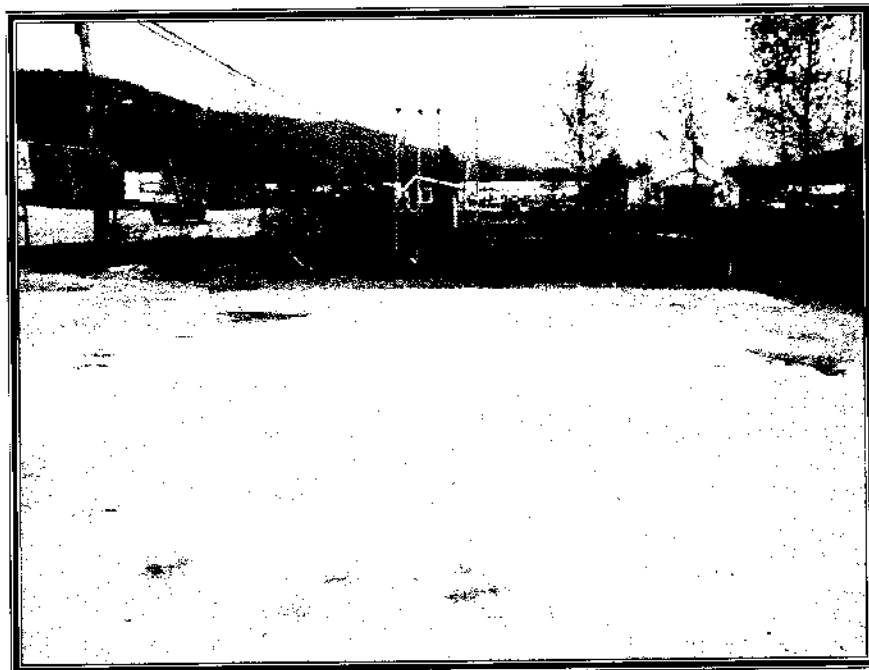
3,000, 4,000 and 6,250-gallon tanks installed in 1984-86. These tanks are all in violation of State and Federal law mandating the removal of all USTs installed prior to 1989. They are currently out of use and are labeled with 'DO NOT FILL' tags issued from the VDEC. We were unable to access all three tanks, however at least one the three still contains product. The pumps connected to the tanks have been removed. It is unknown if the piping still exists.

Photo 6: Former and current UST locations (north side of property),
Merchants Bank information booth in background

- Submit this report to Mr. Robert Haslam, Project Manager for this Site with the Sites Management Section (SMS).
- Proceed with the removal of the three USTs. Once the USTs are removed from the Site, a more detailed subsurface investigation should be conducted to determine the extent and severity of contamination.

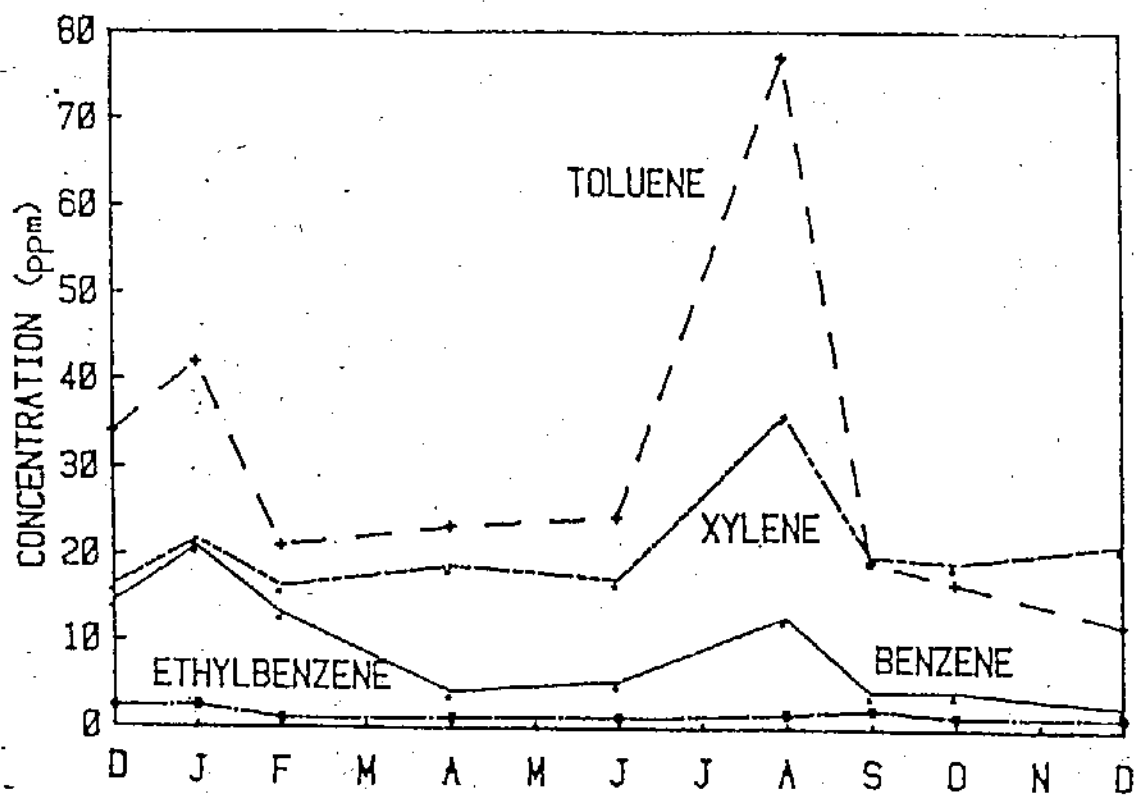
Figure 3: Concentrations of benzene, toluene, ethylbenzene and xylenes in monitoring well 4, Hardwick Kwik Stop
